Inspection Report

Minerals Regulatory Program

Mine Name: Bingham Canyon
Operator Name: Kennecott Utah Copper

Permit number: M0350002
Inspection Date: May 4, 2006
Time: 9:45-10:20 AM

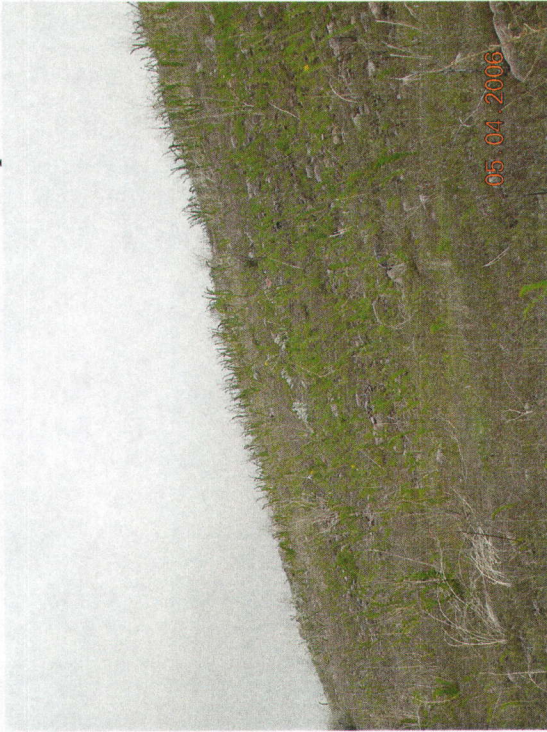
Two of the prospective borrow areas have a soil layer with some degree of organic matter accumulation. The first of these is composed mostly of alluvial material, and the second has bedrock under the soil. The third area also has alluvial material, but Mr. Payne said the surface layers have been stripped from this area. The third area, despite having had soil stripped, has the best vegetation cover, primarily introduced perennial grasses.

Photo 1. The first alluvial area where we walked.

The alluvial deposits contain enough unconsolidated material that I believe revegetation success is likely without saving soil in these areas. If the area with bedrock is used as borrow, I suggest using some of the alluvial material as soil.

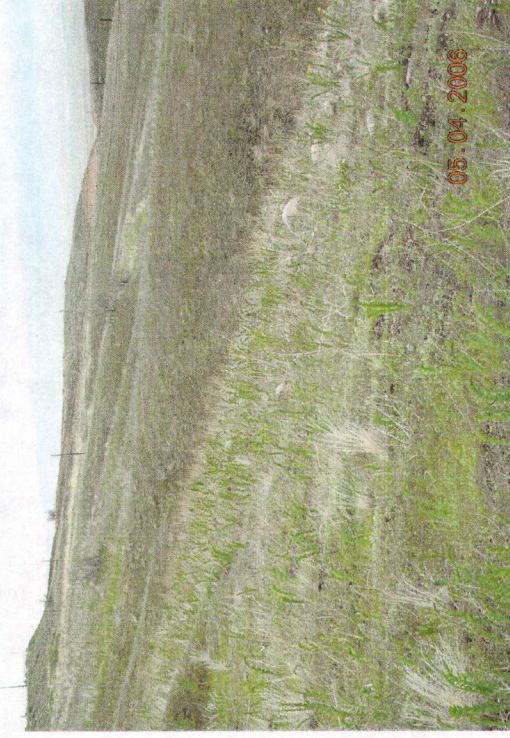
Photo 2. This area is underlain by bedrock.

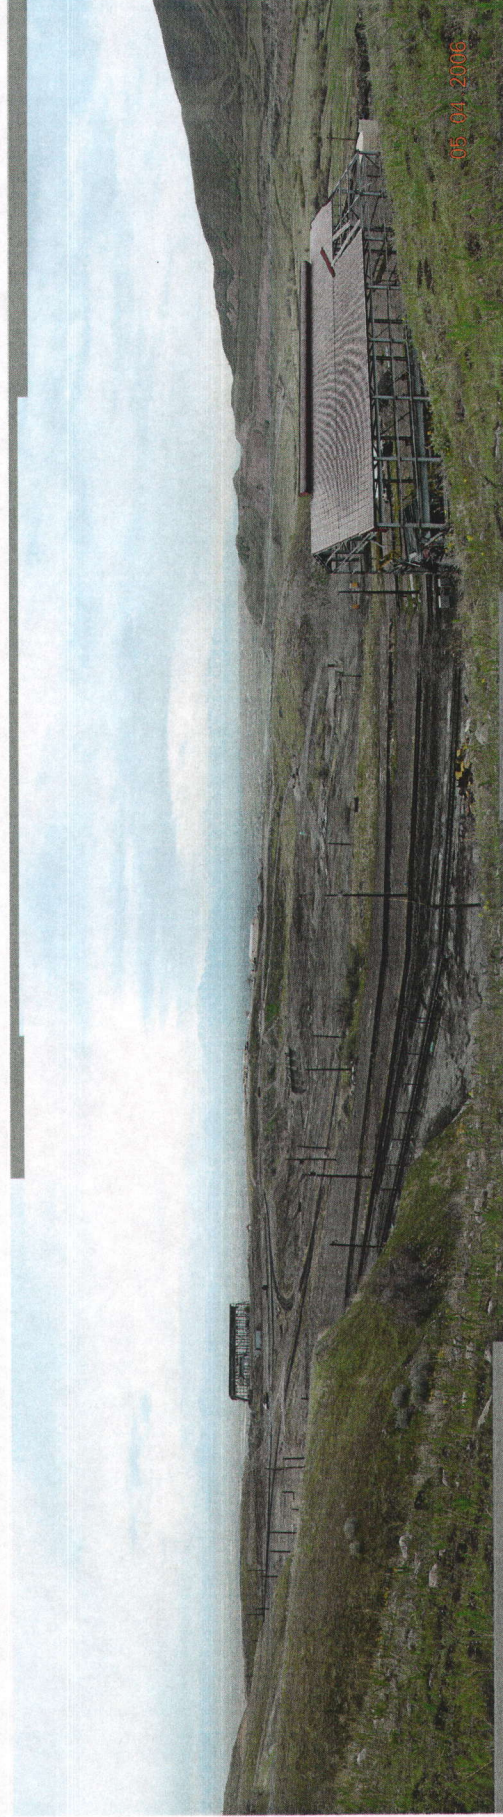
Photo 3. A panorama of the area being reclaimed. The bedrock area is in the foreground, the first alluvial area is near the right/center, and the second alluvial area is near the middle of the picture.
